# Putnam County Complete Street Study

Prepared for  
Putnam County Planning, Development and  
Public Transportation

Prepared by  
AKRF, Inc.

June 2024

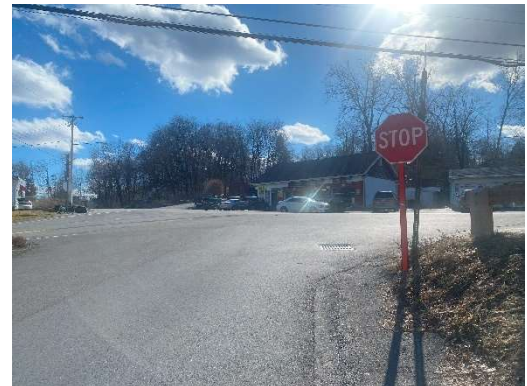
**Figure 2 – Lakeshore Drive East Approach**

The lack of a stop bar on the Lakeshore Drive East approach (**Figure 2**) along with the stop sign being positioned over 30 feet away from the edge line of Towners Road along with the significant up grade made sight distance and judging gaps in traffic challenging without travelling a significant distance past the stop sign.

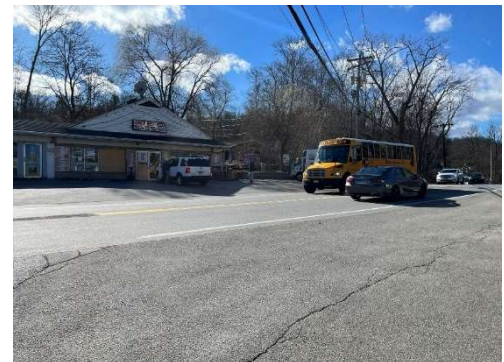
**Figure 3 – School Bus Drop-Off**

A school bus was observed (**Figure 3**) dropping of students on Towners Road immediately west of the intersection on the south side. Parents and students crossed at that point to access businesses on the north side. Due to the large parking/driveway aprons, the area where pedestrians are exposed to traffic is very large and there are no safe places to wait for gaps in traffic to cross. Due to Towners Road not being stop controlled, gaps in traffic to cross were more challenging to find.

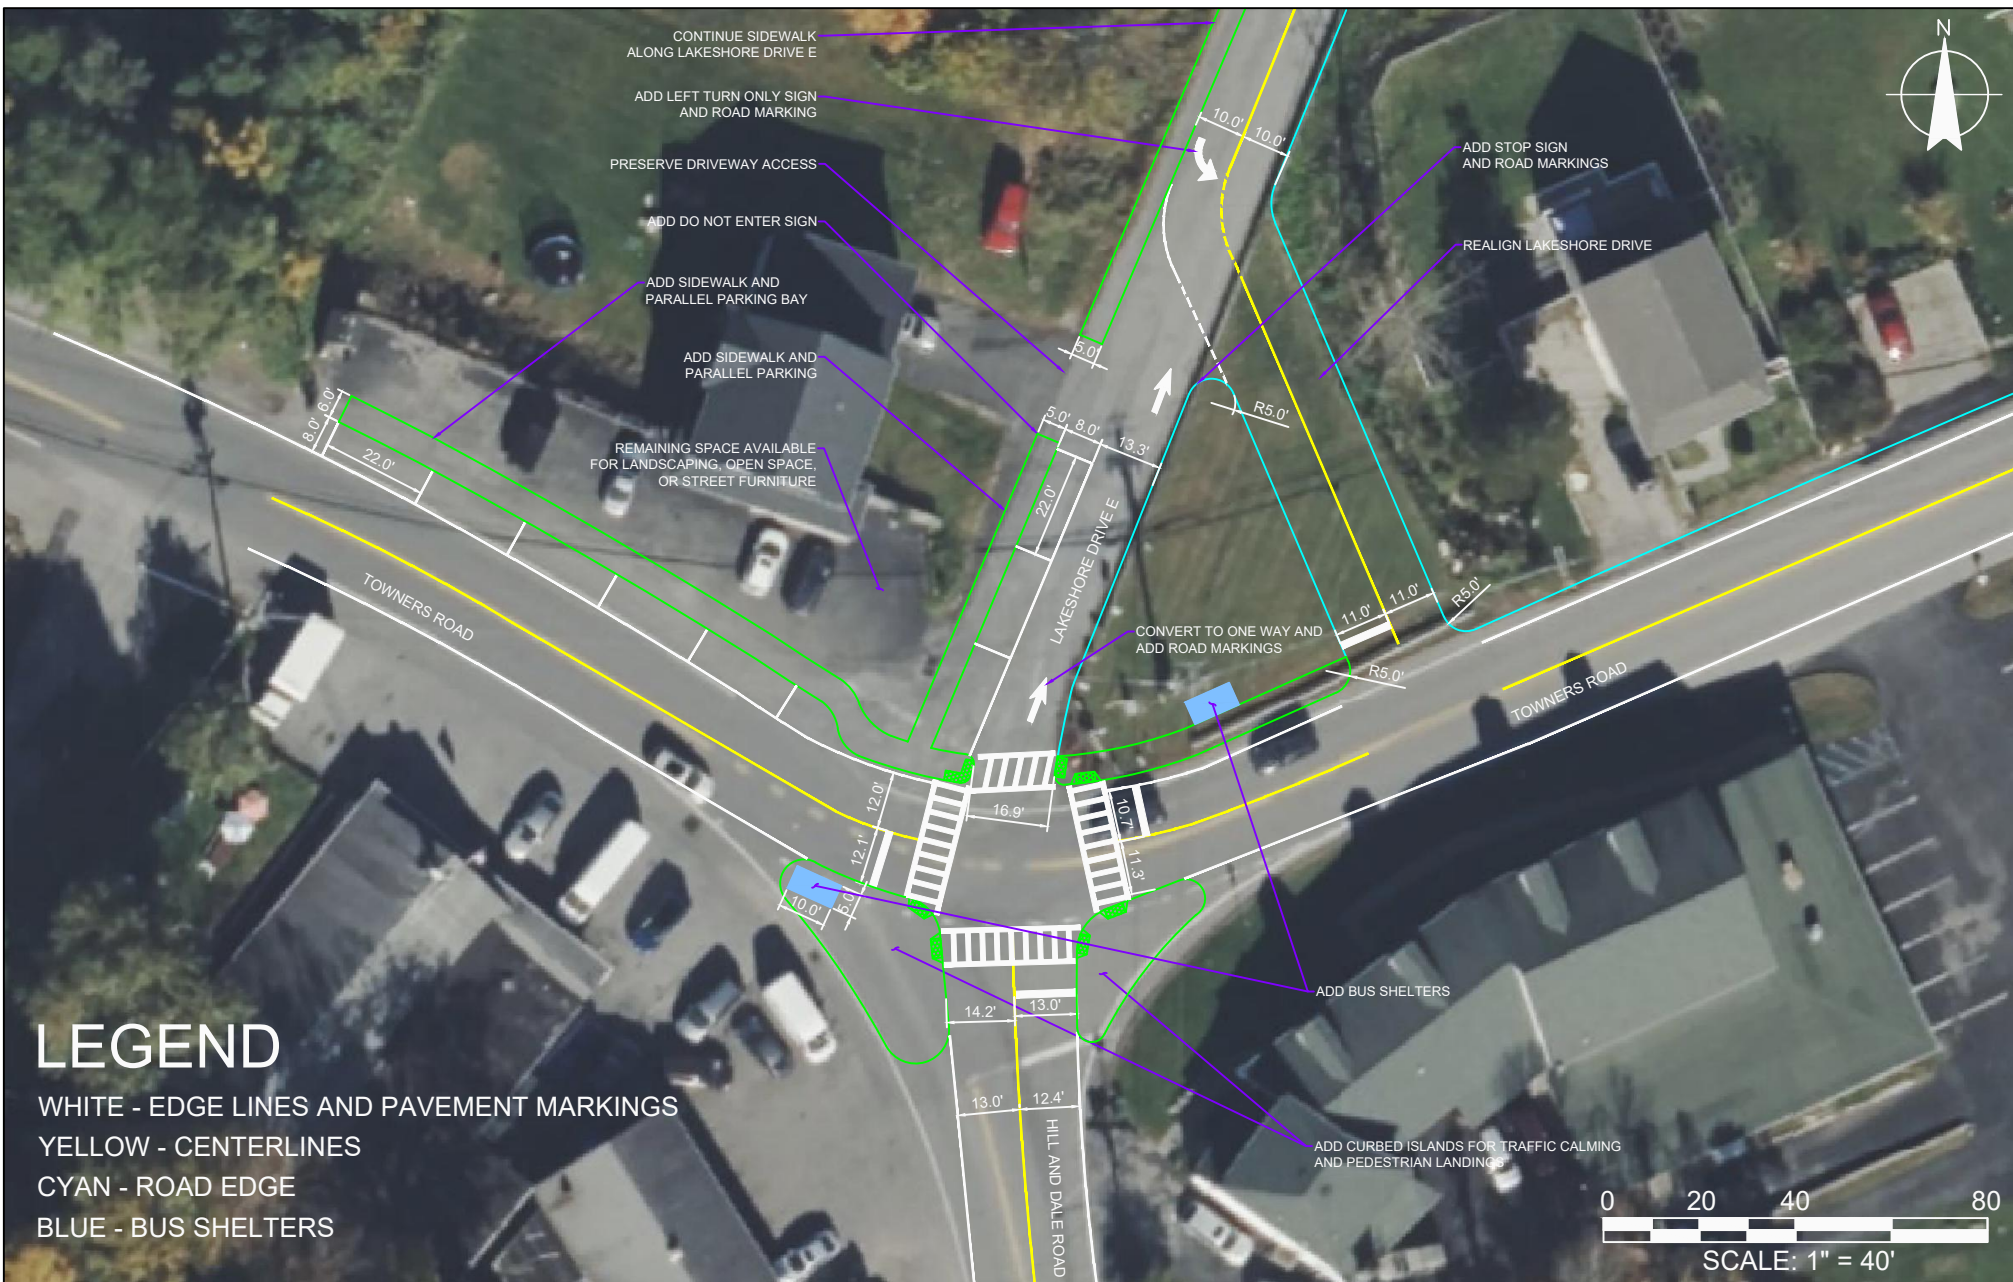
The proposed improvements focused on addressing the geometric deficiencies of the intersection which were contributing to the crash history and driver confusion (see conceptual plan presented below). By realigning Lakeshore Drive East through public land and converting a portion Lakeshore Drive East to a one-way northbound roadway with on-street parking, the single four-leg intersection is converted into two T-intersections. The intersection of Towners Road and Hill and Dale Road would be all-way stop controlled. At the intersection of Towners Road and the realigned Lakeshore Drive East, Towners Road has free operation and Lakeshore Drive East has a stop sign.

The intersection is tightened with striping and curbed islands with pedestrian landings on the south side of the Towers Road/Hill and Dale intersection to decrease turn radii and bring the intersection closer to 90 degrees. Based on field observations, vehicle operations at Gino's Deli and JPE Automobile Repair should not be impacted with the curbed islands but would need to be further investigated if the concept is progressed to a design phase. Crosswalks would be provided at each leg of the Towners Road and Hill and Dale Road intersection, enhanced with "Yield to Pedestrians" signage.

Sidewalks would be provided on the north side of Towners Road, which would also provide an opportunity to install bus shelters for the Putnam Area Rapid Transit's PART 5 route.

The sidewalk adjacent to Parlor 109 would remove access to the existing parking spaces. To replace the parking, eight on-street parallel parking spaces (five on Towners Road and three on the converted Lakeshore Drive East roadway) would be provided.

In addition to the sidewalks on Towners Road, a 5 foot sidewalk could also be provided along Lakeshore Drive East to connect to residential and recreational land uses further north.

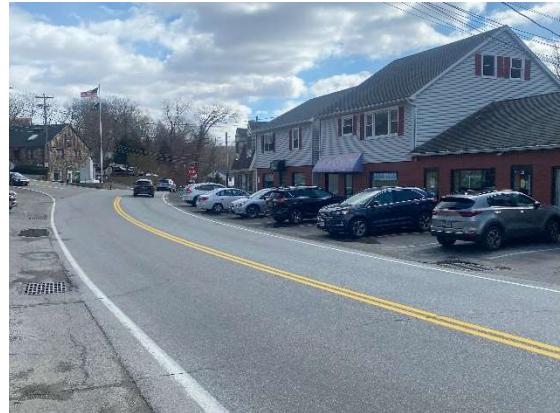
**Figure 4 – Perpendicular Parking along Fairfield Drive**

The perpendicular parking along the south side of Fairfield Drive (**Figure 4**) requires drivers to back out into the travel lane with limited visibility, often relying on other drivers to stop to let them out. Four near misses were witnessed during the observation period at lunch hour. At the intersection, the Haviland Drive approach does not have a stop line and the stop sign does not indicate that it is an all way stop. The channelized right turn from Fairfield Drive to Haviland Drive also does not have a stop line.

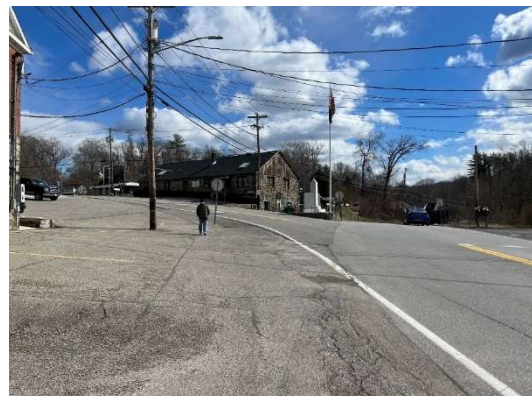
**Figure 5 – Pedestrian Walking in Front of Fire Station**

The only crosswalk in the vicinity of the intersection is over 200 feet away and lands in front of an auto repair shop, 80 feet away from the private sidewalk in front of the restaurants and other small businesses along the south side of Fairfield Drive. On the north side, due to the 300 feet

of driveway apron in front of the fire station, pedestrians have no protection from traffic while walking between the commercial area and nearby residential areas (**Figure 5**).

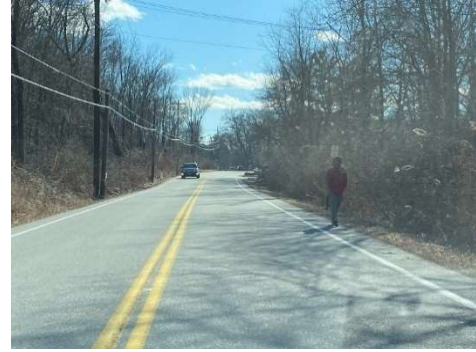
**Figure 6 – Pedestrian Walking on Shoulder along Baldwin Place Road**

During field observations several school age pedestrians were seen walking along the edge of Baldwin Place Road, both adjacent to the school campus as well as south of the school campus. **(Figure 6)** Due to the lack of pedestrian facilities or a road shoulder, these pedestrians were exposed to relatively high volumes of high-speed traffic.

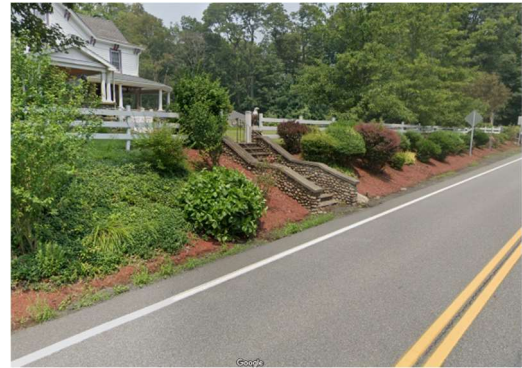
**Figure 7– Right-of-Way Constraints**

The proposed improvements, see conceptual plans below, focus on adding pedestrian facilities to safely accommodate the demand for pedestrian access to the school from nearby residential neighborhoods. This includes a sidewalk along the east side of Baldwin Place Road between Muscoot Road and Gleneida Boulevard and on the west side of Baldwin Place Road between Gleneida Boulevard and Myrtle Ave. This would provide safe pedestrian connectivity to the school from several residential streets along Baldwin Place Road. While the was pedestrian demand observed on the west side of the roadway, the recommended sidewalk south of Gleneida Avenue would likely require right of way acquisition and/or shifting Baldwin Place Road based on some of the existing physical constrains. For example, there is landscape and stairway to a private residence near Ryan Court (**Figure 7**) that would require right of way acquisition or roadway alignment modifications.

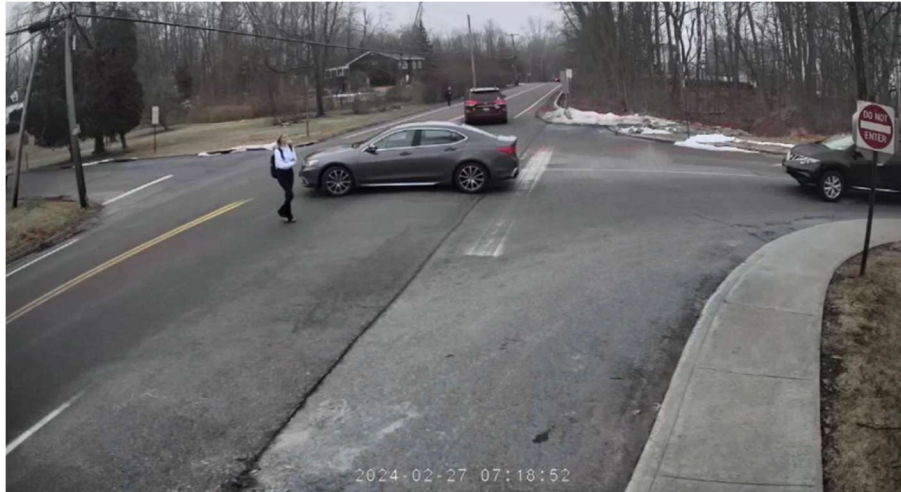
***Figure 8 – Pedestrian Crossing Baldwin Place Road at Gleneida Boulevard***

Additionally, high visibility crosswalks are recommended at all driveway crossings. In addition, due to the high volume of pedestrians was observed crossing Baldwin Place Road from Gleneida Boulevard to the High School driveway (**Figure 8**), a high visibility crosswalk with Rectangular Rapid Flashing Beacons (RRFB) is recommended at this crossing point. As an alternative, a traffic signal at this location can considered which will need to be assessed future signal warrant studies.

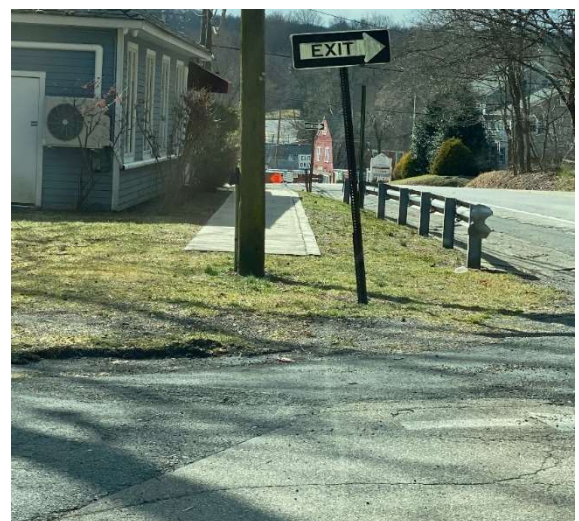
*Figure 9 – Sidewalk Dead End*

There are no pedestrian facilities along Oscawana Lake Road in the corridor except for a short stretch of sidewalk that runs north from Enloe Street and dead ends 25 feet before reaching the library parking lot (see **Figure 9**). Much of the corridor appears to have adequate space along the road edge for pedestrian facilities with the exception of the intersection with Gilbert Lane which is at a curve in Oscawana Lake Road and has a guardrail on the east edge of the road and vegetation directly up to the edge of the west edge of the road.

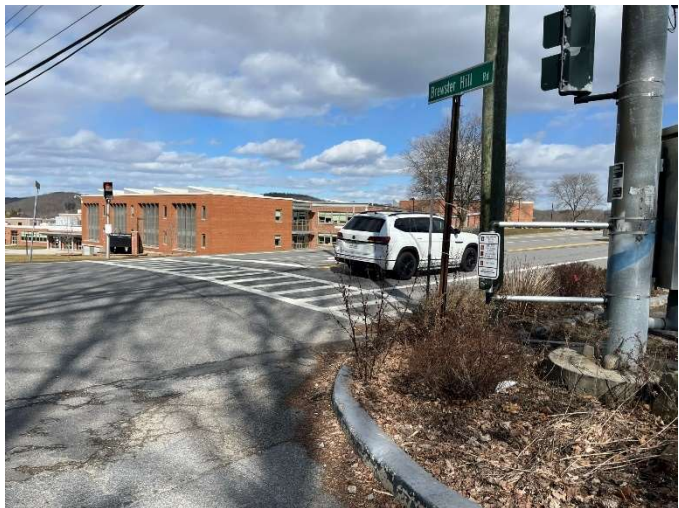
**Figure 10 – Route 312 Crosswalk and Pedestrian Push Button**

Due to a crest along Route 312 approximately 350 feet from the intersection, it was determined that a midblock crossing is infeasible, and the existing crossing location is the safest location for crossing between the school and the deli and gas station. The landing areas of the crosswalk were observed to be deficient in terms of safety and accessibility. On the south side, the crosswalk lands at a curbed landscaped area which is likely not traversable when the landscaping plants are grown. Between the curb and the travel lane there is an 8-foot shoulder which is likely used to access the driveway from the crosswalk. The pedestrian call button on the south side is mounted facing Brewster Hill Road, a significant distance from the crosswalk landing, requiring more traversing through landscaping or walking along the travel lane to access the button (see **Figure 10**).

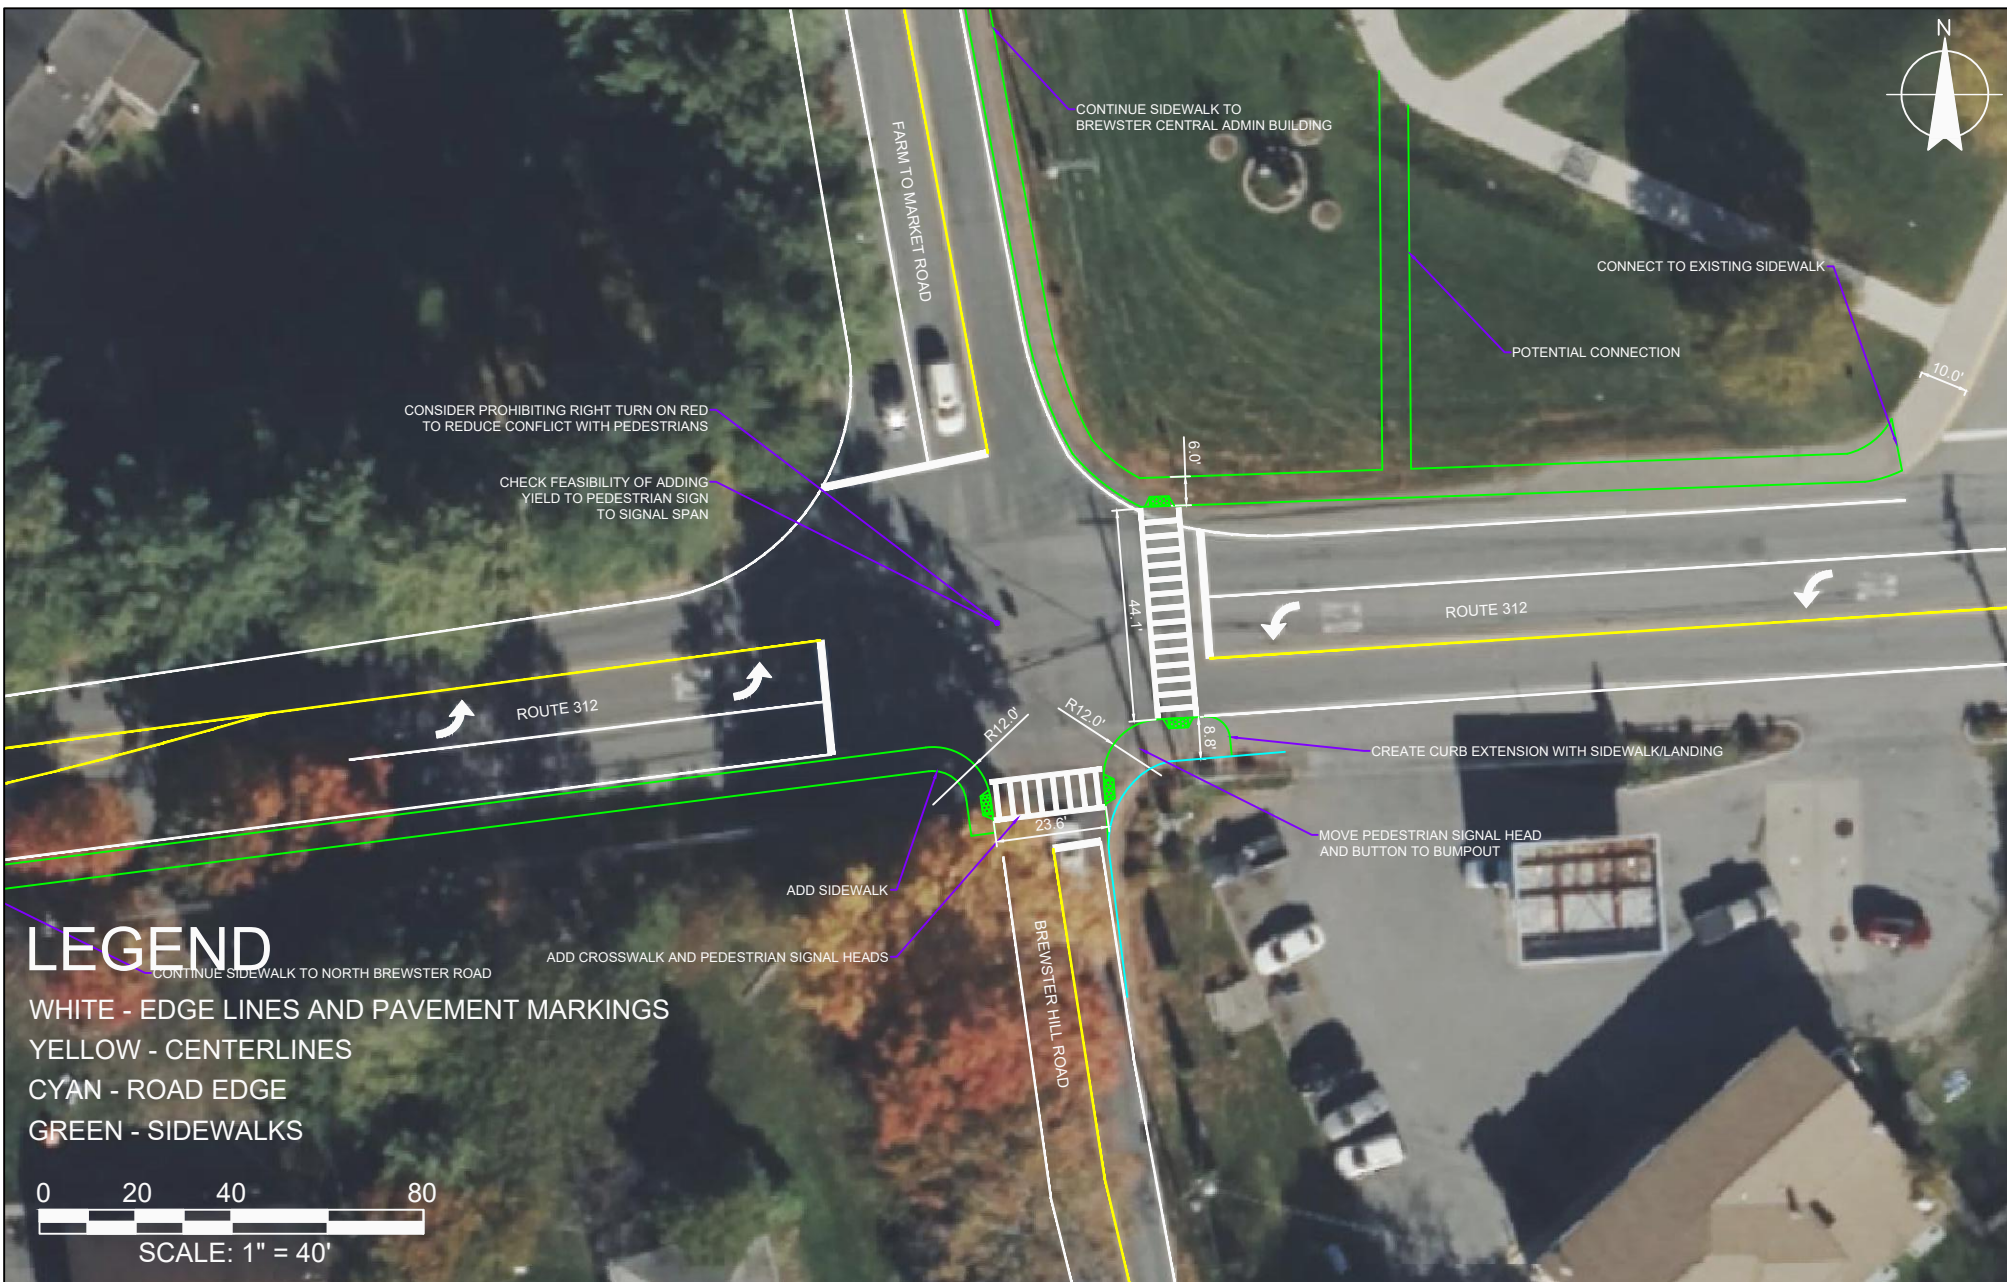
While no desire line was observed, the most direct path from the school walkway to the crosswalk is across a lawn. The potential connection as shown saves 175 feet of walking distance compared to following the existing and proposed sidewalk. The lawn is significantly graded so this path would require stairs but is a potential opportunity to discuss with the school at a later date if there is an observed desire line along that path.

Sidewalks should also be extended north on the east side of Farm to Market Road to the CV Starr Intermediate School entrance. To avoid the utility poles along the east side of Farm to market Road the sidewalk would be located within the school's right of way.

In addition, sidewalks should be extended to the west on the south side of Route 312 to North Brewster Road to provide a pedestrian route between the school and the North Brewster Deli & Market and La Strada Pizza and Pasta. This could be further enhanced with a sidewalk along the east side of North Brewster Road.

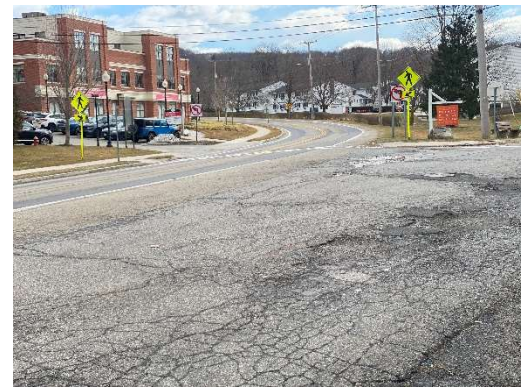
**Figure 11 – Chestnut Street Intersection**

While there were no observed traffic operation issues, the intersection configurations are not ideal in accommodating traffic movements. At Chestnut Street, the roadway angles promote a high speed turning movement from Route 9D traveling eastbound onto Chestnut Street (**Figure 11**). In addition, vehicles exiting Chestnut Street making a left onto Route 9D has limited sight distance on vehicles traveling westbound on Route 9D.

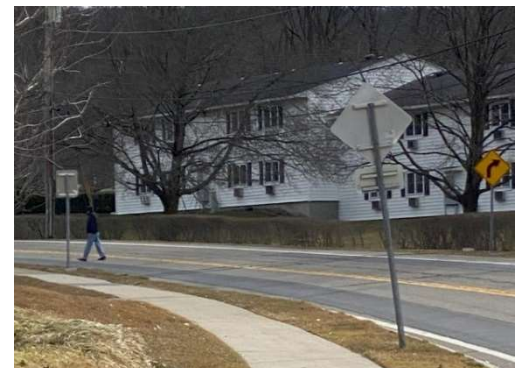
**Figure 12 – Pedestrian Crossing Midblock**

While a marked crosswalk is provided at Chestnut Street, multiple pedestrians were observed crossing mid-block between the multifamily residential area to the south and the sidewalk on the north side of Route 9D (**Figure 12**).

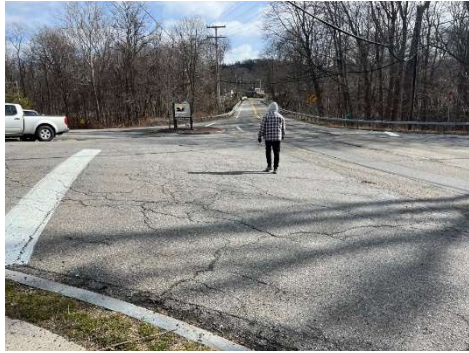
**Figure 13– Pedestrian Crossing Paulding Avenue**

The intersections of Route 9D with Chestnut Street/Paulding Avenue/Bank Street at the east end of the study area along with a private driveway (Downey Energy) form a large area exposing crossing pedestrians to traffic which can take turns at high speed due to the large turn radii (**Figure 13**). There are also no marked

pedestrian crossings on any of the approaches.

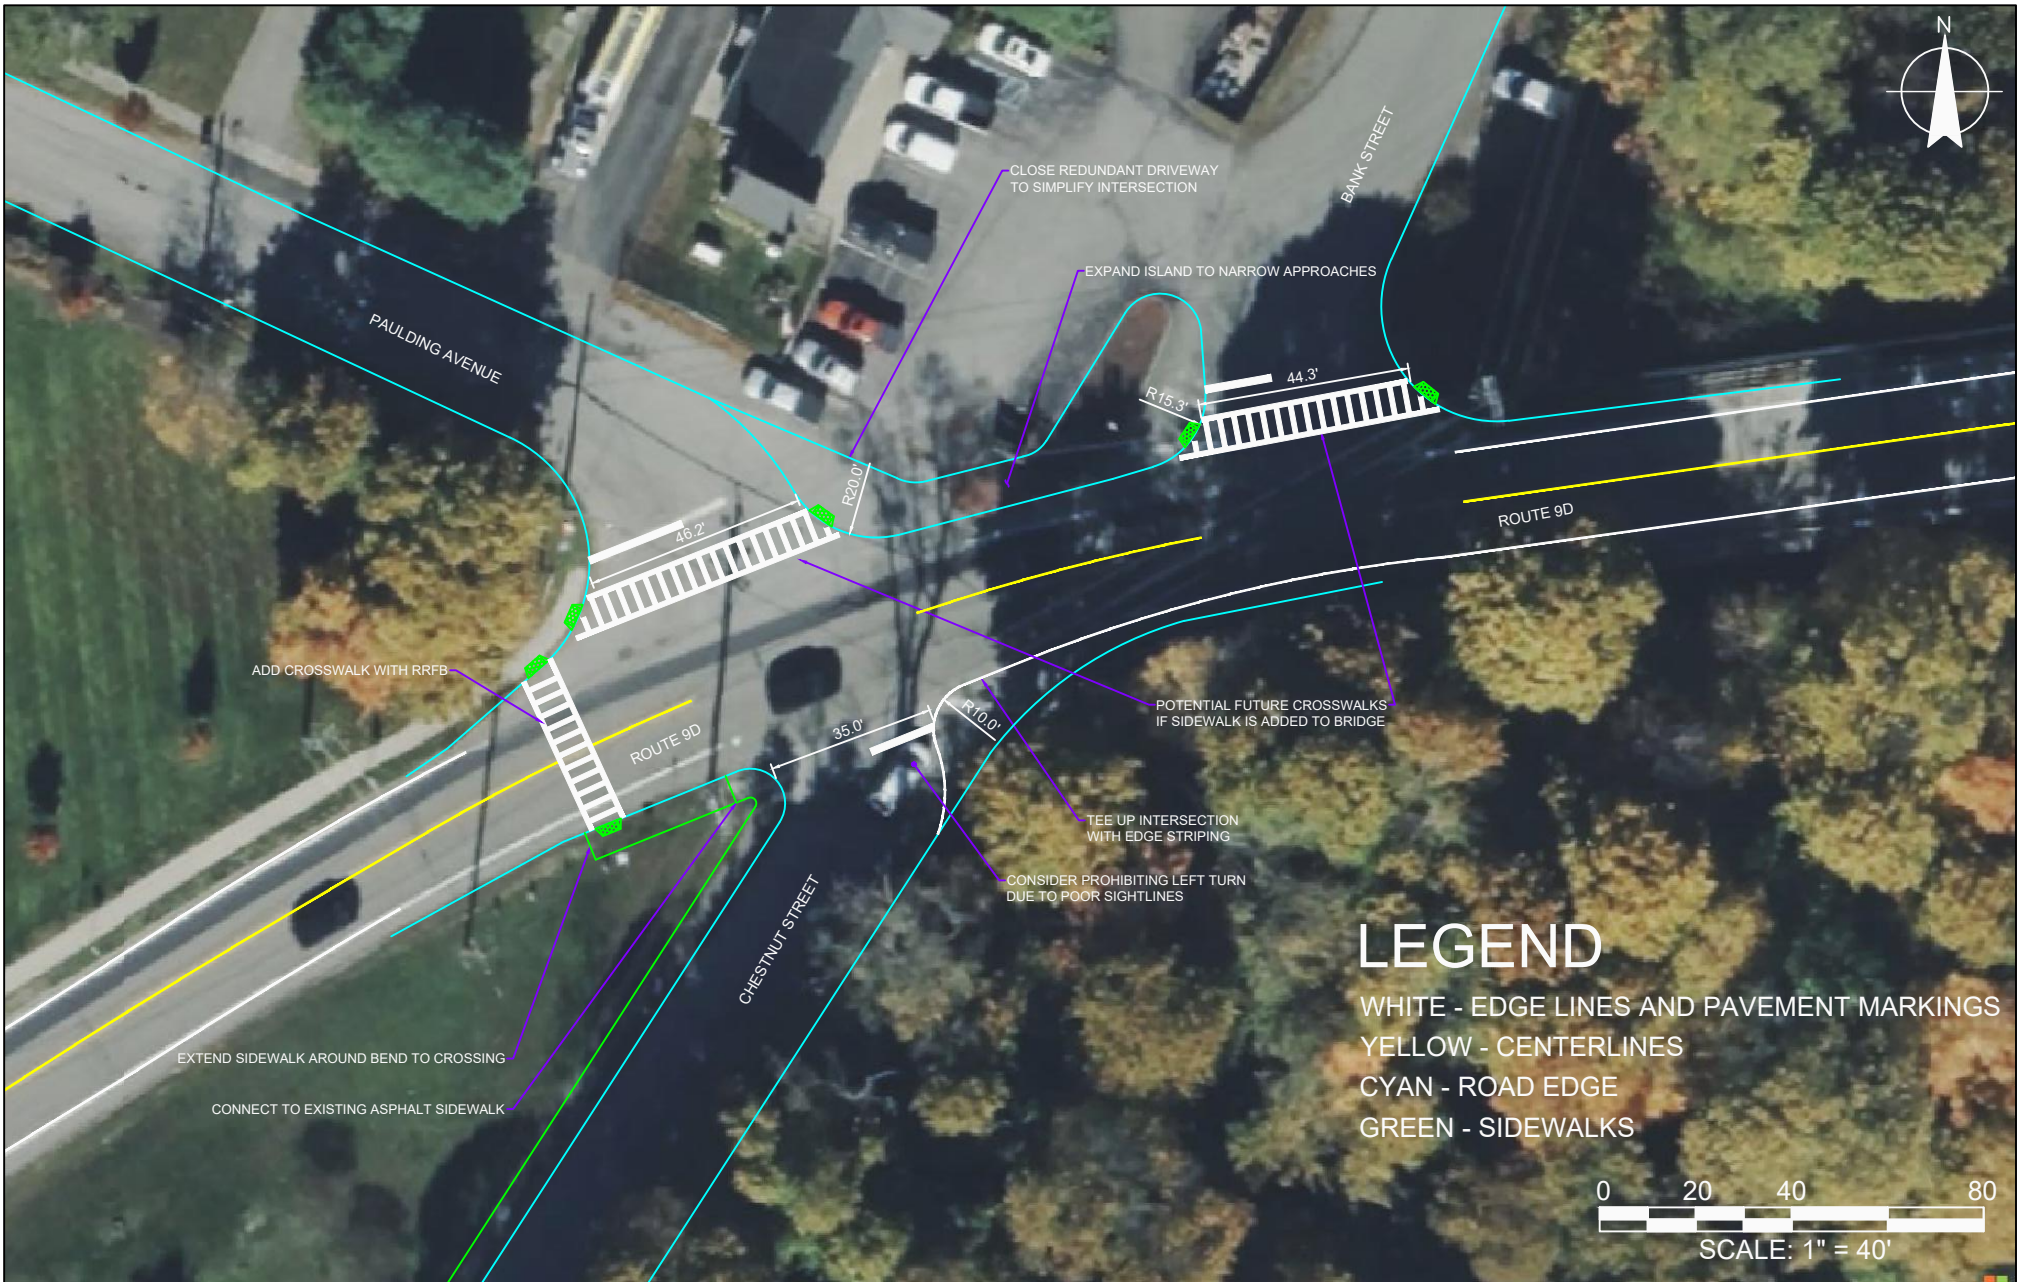
Lastly, in response to observations of pedestrians crossing between the east and west intersections of this corridor, a midblock crossing is proposed. Two desire lines were observed between private walkways in the housing complex on the south side of Route 9D to gaps in the hedges along the street. The options for

the proposed crosswalks are at approximately 500 feet and 700 feet east of the marked crosswalk at Chestnut Street along Route 9D. The proposed crosswalk at Paulding Ave/Chestnut Street is 1,100 feet from the Chestnut Street crosswalk. There is potential to work with the housing complex owner to formalize the observed desire lines to further connect the north and south sides of the street and safely accommodate the observed demand for crossing between these areas.
