### INTERSECTION IMPROVEMENT FEASIBILITY STUDY

CLIENT: Putnam County Highway Department  
842 Fair Street, Carmel, NY 10512

<b>Project:</b>	Putnam County Intersection Improvements
<b>Location:</b>	Putnam County (Various Locations)
<b>Intersection:</b>	Fishkill Rd (CR 10) at State Route 301
<b>GPS Coord.:</b>	41.42769, -73.93995
<b>Traffic Control:</b>	Stop Sign (SB)
<b>Traffic Control Notes (if applicable):</b>	None
<b>Other Intersection Notes (if applicable):</b>	No Pedestrian Crossings. Healy Road is one-way out of intersection.

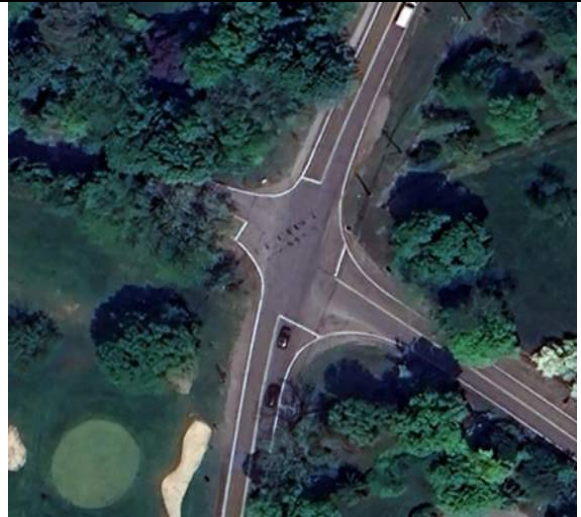
<b>Project:</b>	Putnam County Intersection Improvements
<b>Location:</b>	Putnam County (Various Locations)
<b>Intersection:</b>	Lower Station Rd (CR 12) at State Route 9D
<b>GPS Coord.:</b>	41.37612, -73.94384
<b>Traffic Control:</b>	Signalized
<b>Traffic Control Notes (if applicable):</b>	Permitted/Protected Southbound Left Turn
<b>Other Intersection Notes (if applicable):</b>	No Pedestrian Crossings.

State Route 9D			State Route 9D			Lower Station Rd (CR 12)			State Route 403		
	Northbound			Southbound			Eastbound			Westbound		
	Left	Thru	Right	Left	Thru	Right	Left	Thru	Right	Left	Thru	Right
Lane Assignments:	<-1->				<-1->			<-1->			<-1->	
Lane Widths:	12'			12'			11'			11'		
Turn Bay Lengths:	-			-			-			-		
Speed Limits:	40 mph			40 mph			30 mph			45 mph

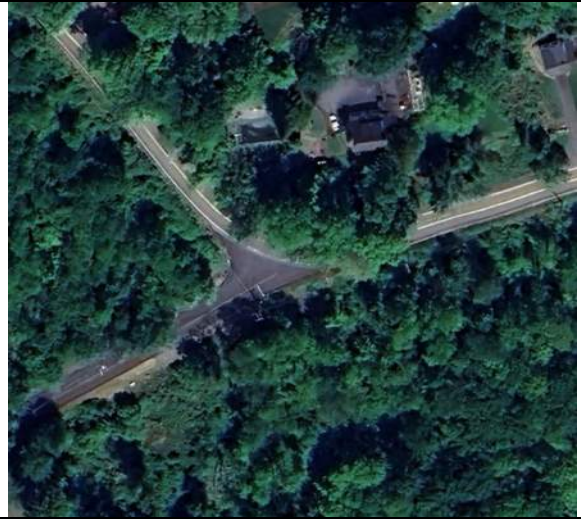
<b>Project:</b>	Putnam County Intersection Improvements
<b>Location:</b>	Putnam County (Various Locations)
<b>Intersection:</b>	Drewville Rd (CR 36) at Weber Hill Rd
<b>GPS Coord.:</b>	41.38740, -73.69267
<b>Traffic Control:</b>	Stop Sign (NB)
<b>Traffic Control Notes (if applicable):</b>	None
<b>Other Intersection Notes (if applicable):</b>	No Pedestrian Crossings. Sharp curve on Drewville Rd.

Drewville Rd (CR 36)			Weber Hill Rd			Drewville Rd (CR 36)					
	Northbound			Southbound			Eastbound			Westbound		
	Left	Thru	Right	Left	Thru	Right	Left	Thru	Right	Left	Thru	Right
Lane Assignments:					<-1->			<-1				1->
Lane Widths:					11'			11'				11'
Turn Bay Lengths:					-			-				-
Speed Limits:					40 mph			30 mph				40 mph

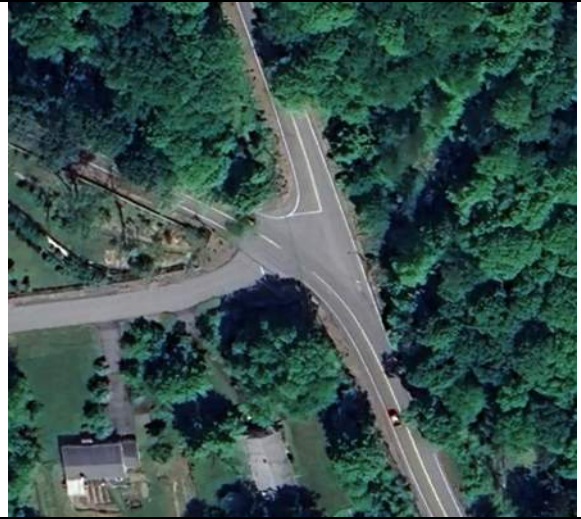
<b>Project:</b>	Putnam County Intersection Improvements
<b>Location:</b>	Putnam County (Various Locations)
<b>Intersection:</b>	Croton Falls Rd (CR 34) at West Shore Dr
<b>GPS Coord.:</b>	41.36587, -73.68236
<b>Traffic Control:</b>	Stop Sign (EB, WB)
<b>Traffic Control Notes (if applicable):</b>	None
<b>Other Intersection Notes (if applicable):</b>	No Pedestrian Crossings.

Croton Falls Rd (CR 34)			Croton Falls Rd (CR 34)			Munich Rd			West Shore Dr (CR 38)		
	Northbound			Southbound			Eastbound			Westbound		
	Left	Thru	Right	Left	Thru	Right	Left	Thru	Right	Left	Thru	Right
Lane Assignments:		<-1->			<-1->			<-1->			<-1->	
Lane Widths:		11'			11'			10'			11'	
Turn Bay Lengths:		-			-			-			-	
Speed Limits:	35 mph			35 mph			30 mph			45 mph

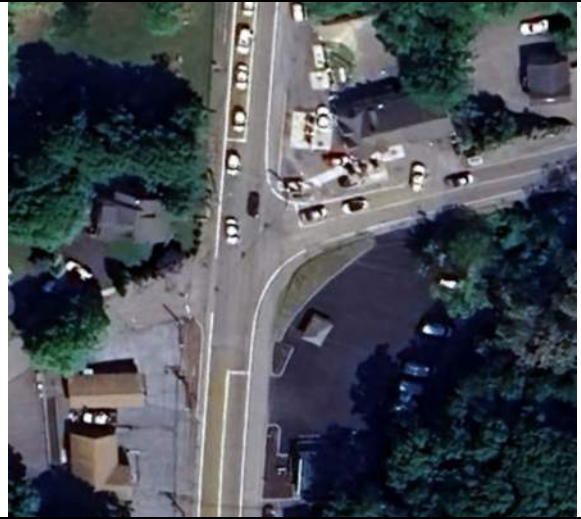
<b>Project:</b>	Putnam County Intersection Improvements
<b>Location:</b>	Putnam County (Various Locations)
<b>Intersection:</b>	Towners Rd at State Route 52
<b>GPS Coord.:</b>	41.44984, -73.67219
<b>Traffic Control:</b>	Signalized
<b>Traffic Control Notes (if applicable):</b>	None
<b>Other Intersection Notes (if applicable):</b>	No Pedestrian Crossing. Several Adjacent Pull-in Back-up Parking Lots.

State Route 52			State Route 52			Nichols St			Towners Rd		
	Northbound			Southbound			Eastbound			Westbound		
	Left	Thru	Right	Left	Thru	Right	Left	Thru	Right	Left	Thru	Right
Lane Assignments:		<-1->			<-1->			<-1->			<-1->	
Lane Widths:		12'			12'			10'			11'	
Turn Bay Lengths:		-			-			-			-	
Speed Limits:	40 mph			40 mph			30 mph			30 mph

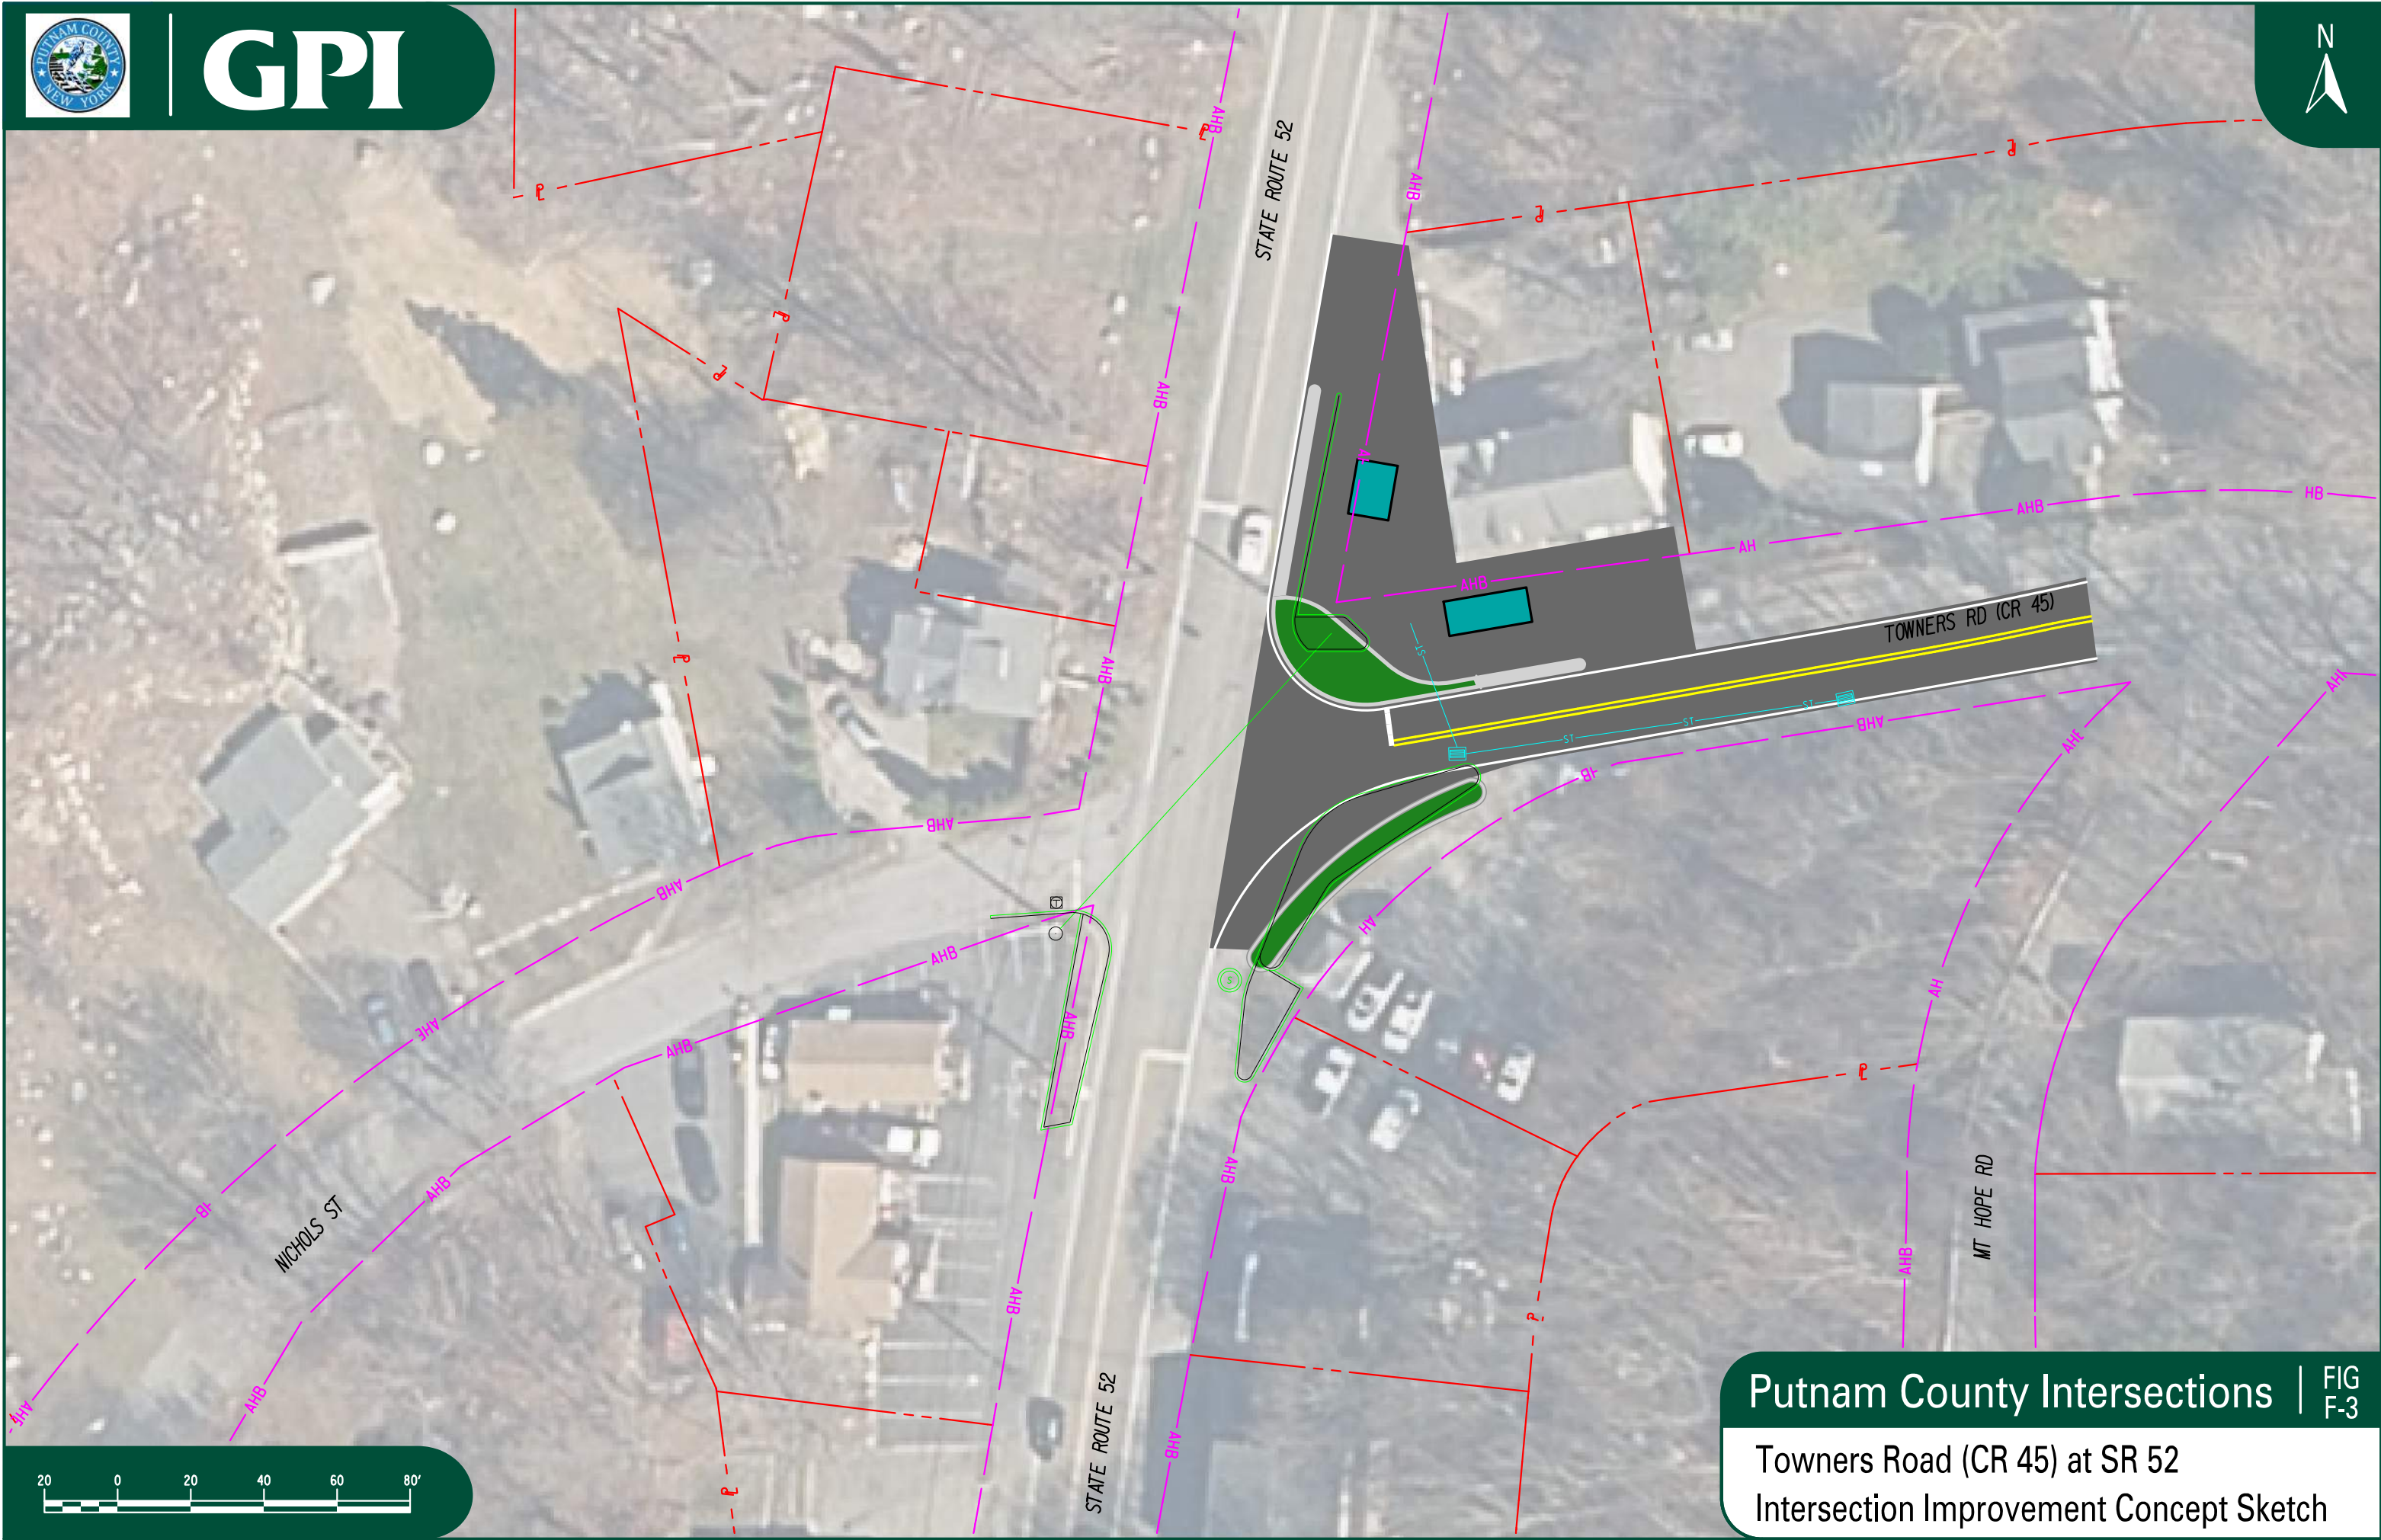
Putnam County Intersections | FIG F-3

Towners Road (CR 45) at SR 52  
Intersection Improvement Concept Sketch

Estimated Construction Cost
Recommended Improvements:	Stop bar relocation and "Stop Here on Red" sign	\$2,000
<i>Optional "Feasible" Alternatives:</i>	<i>Realign the eastern Towners Rd approach</i>	<i>\$570,000</i>
Implementation Priority:	Medium

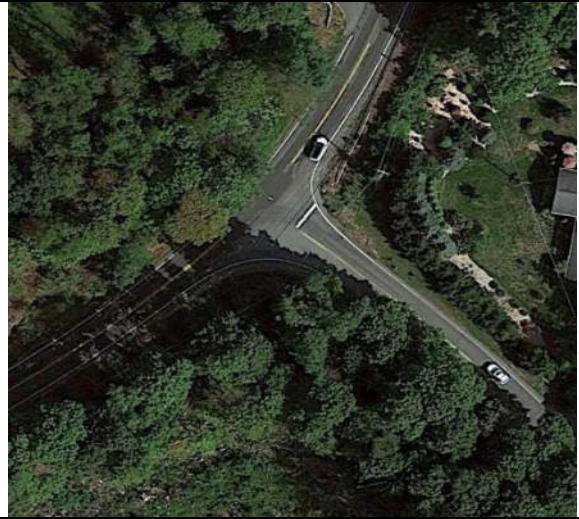
<b>Project:</b>	Putnam County Intersection Improvements
<b>Location:</b>	Putnam County (Various Locations)
<b>Intersection:</b>	State Route 311 at Fair St (CR 60)
<b>GPS Coord.:</b>	41.47462, -73.63881
<b>Traffic Control:</b>	Stop Sign (NB)
<b>Traffic Control Notes (if applicable):</b>	None
<b>Other Intersection Notes (if applicable):</b>	No Pedestrian Crossings.

Fair St (CR 60)			-			State Route 311			State Route 311		
	Northbound			Southbound			Eastbound			Westbound		
	Left	Thru	Right	Left	Thru	Right	Left	Thru	Right	Left	Thru	Right
Lane Assignments:	<-1->							1->			<-1	
Lane Widths:	11'							11'			11'	
Turn Bay Lengths:	-							-			-	
Speed Limits:	40 mph						45 mph			45 mph

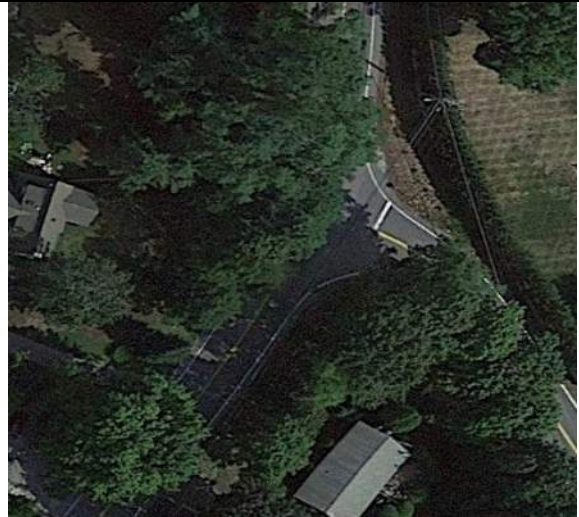
<b>Project:</b>	Putnam County Intersection Improvements
<b>Location:</b>	Putnam County (Various Locations)
<b>Intersection:</b>	State Route 311 at Cornwall Hill Rd (CR 64)
<b>GPS Coord.:</b>	41.50997, -73.61645
<b>Traffic Control:</b>	Stop Sign (NB)
<b>Traffic Control Notes (if applicable):</b>	None
<b>Other Intersection Notes (if applicable):</b>	No Pedestrian Crossings.

Cornwall Hill Rd (CR 64)			-			State Route 311			State Route 311			
	Northbound			Southbound			Eastbound			Westbound			
	Left	Thru	Right	Left	Thru	Right	Left	Thru	Right	Left	Thru	Right	
Lane Assignments:		<-1->						1->			<-1		
Lane Widths:		10'						11'			11'		
Turn Bay Lengths:		-						-			-		
Speed Limits:		40 mph						30 mph			30 mph

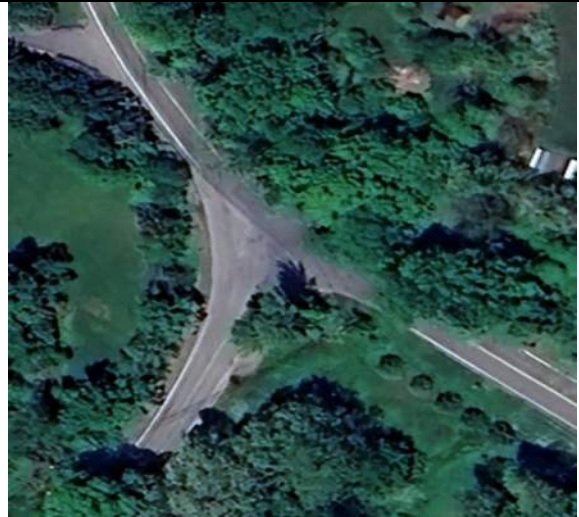
<b>Project:</b>	Putnam County Intersection Improvements
<b>Location:</b>	Putnam County (Various Locations)
<b>Intersection:</b>	North Salem Rd (CR 55) at Fields Ln
<b>GPS Coord.:</b>	41.36676, -73.61011
<b>Traffic Control:</b>	Stop Sign (EB)
<b>Traffic Control Notes (if applicable):</b>	None
<b>Other Intersection Notes (if applicable):</b>	No Pedestrian Crossings.

North Salem Rd			North Salem Rd			Fields Ln			-		
	Northbound			Southbound			Eastbound			Westbound		
	Left	Thru	Right	Left	Thru	Right	Left	Thru	Right	Left	Thru	Right
Lane Assignments:		<-1			1->			<-1->				
Lane Widths:		11'			11'			11'				
Turn Bay Lengths:		-			-			-				
Speed Limits:	Unposted			Unposted			30 mph

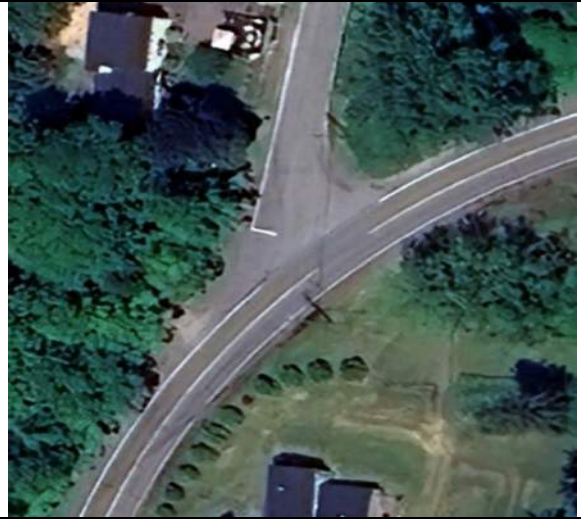
<b>Project:</b>	Putnam County Intersection Improvements
<b>Location:</b>	Putnam County (Various Locations)
<b>Intersection:</b>	Milltown Rd (CR 54) at Gage Rd
<b>GPS Coord.:</b>	41.41645, -73.55862
<b>Traffic Control:</b>	Stop Sign (SB)
<b>Traffic Control Notes (if applicable):</b>	None
<b>Other Intersection Notes (if applicable):</b>	No Pedestrian Crossings.

-			Gage Rd			Milltown Rd			Milltown Rd			
	Northbound			Southbound			Eastbound			Westbound			
	Left	Thru	Right	Left	Thru	Right	Left	Thru	Right	Left	Thru	Right	
Lane Assignments:					<-1->			<-1			1->		
Lane Widths:					10'			11'			11'		
Turn Bay Lengths:								-			-		
Speed Limits:					30 mph			35 mph			35 mph

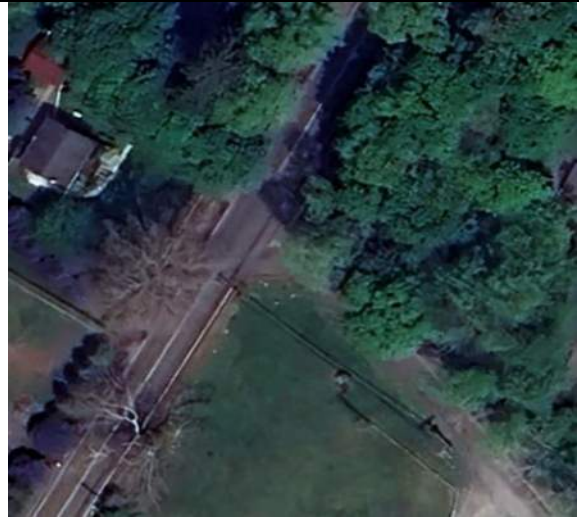
<b>Project:</b>	Putnam County Intersection Improvements
<b>Location:</b>	Putnam County (Various Locations)
<b>Intersection:</b>	Peekskill Hollow Rd (CR 21) at Bryant Pd Rd
<b>GPS Coord.:</b>	41.38935, -73.81335
<b>Traffic Control:</b>	Stop Sign (WB)
<b>Traffic Control Notes (if applicable):</b>	None
<b>Other Intersection Notes (if applicable):</b>	No Pedestrian Crossings.

Peekskill Hollow Rd			Peekskill Hollow Rd			-			Bryant Pond Rd		
	Northbound			Southbound			Eastbound			Westbound		
	Left	Thru	Right	Left	Thru	Right	Left	Thru	Right	Left	Thru	Right
Lane Assignments:		1->			<-1						<-1->	
Lane Widths:		11'			11'						11'	
Turn Bay Lengths:		-			-						-	
Speed Limits:	40 mph			40 mph						30 mph

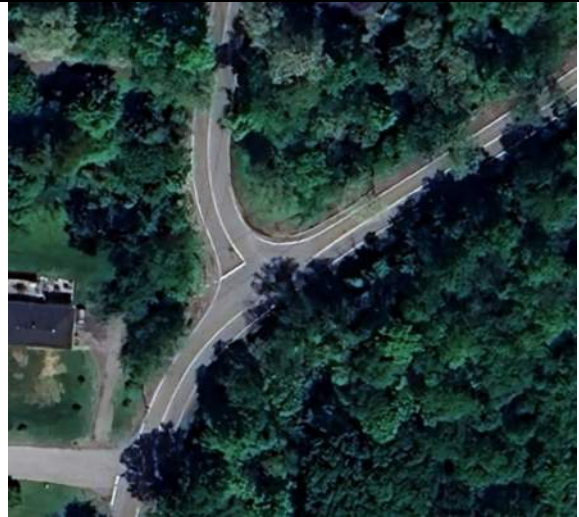
<b>Project:</b>	Putnam County Intersection Improvements
<b>Location:</b>	Putnam County (Various Locations)
<b>Intersection:</b>	Baldwin Pl Rd (CR37) at Myrtle Ave (CR71)
<b>GPS Coord.:</b>	41.36008, -73.76200
<b>Traffic Control:</b>	Stop Sign (EB)
<b>Traffic Control Notes (if applicable):</b>	None
<b>Other Intersection Notes (if applicable):</b>	No Pedestrian Crossings. Close Proximity to Mahopac High School

Baldwin Place Rd			Baldwin Place Rd			Myrtle Ave			-		
	Northbound			Southbound			Eastbound			Westbound		
	Left	Thru	Right	Left	Thru	Right	Left	Thru	Right	Left	Thru	Right
Lane Assignments:		<-1			1->			<-1->				
Lane Widths:		11'			11'			11'				
Turn Bay Lengths:		-			-			-				
Speed Limits:	40 mph			40 mph			30 mph
